DEPARTMENT OF TRANSPORTATION

Quality Assurance and Source Inspection

Contract #: 04-0120F4Cty: SF/ALA Rte: 80 PM: 13.2/13.9File #: 69.28**WELDING INSPECTION REPORT****Resident Engineer:**Pursell, Gary**Address:** 333 Burma Road**City:** Oakland, CA 94607**Report No:** WIR-013533**Date Inspected:** 15-Apr-2010**Project Name:** SAS Superstructure**OSM Arrival Time:** 700**Prime Contractor:** American Bridge/Fluor Enterprises, a JV**OSM Departure Time:** 1900**Contractor:** Zhenhua Port Machinery Company, Ltd (ZPMC), Changxing Island **Location:** Shanghai, China**CWI Name:** Zhao Chen Sun**CWI Present:** Yes No**Inspected CWI report:** Yes No N/A**Rod Oven in Use:** Yes No N/A**Electrode to specification:** Yes No N/A**Weld Procedures Followed:** Yes No N/A**Qualified Welders:** Yes No N/A**Verified Joint Fit-up:** Yes No N/A**Approved Drawings:** Yes No N/A**Approved WPS:** Yes No N/A**Delayed / Cancelled:** Yes No N/A**Bridge No:** 34-0006**Component:** Tower Components**Summary of Items Observed:**

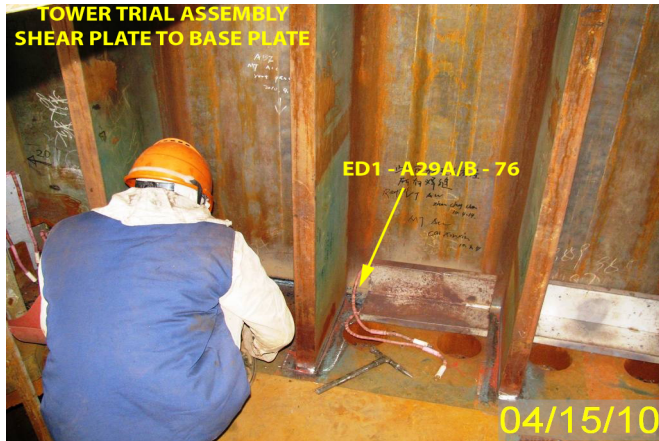
Weld joint # 076 located on base plate to shear plate ED1 – A29A/B between East and North shafts. Welder is identified as 042218. ZPMC Quality Control (QC) Inspector is identified as Li Jun. The welding variables recorded by QC appeared to comply with the WPS – B – T – 2332 – Tc – P5 – F.

(See attached photo)

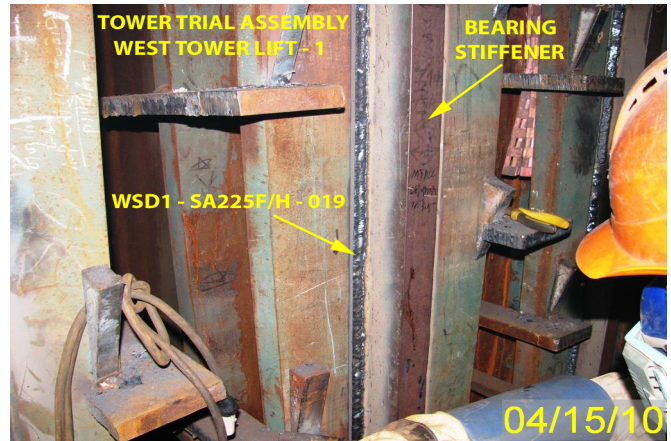
Weld joint # 019 located on West Tower Lift-1 Bearing stiffener WSD1 – SA225F/H. Welder is identified as 046706. ZPMC Quality Control (QC) Inspector is identified as Wang Chuangxin. The welding variables recorded by QC appeared to comply with the WPS – B – T – 2333 – Tc – P4 – F.

(See attached photo)
